ST. FRANCIS RIVER BASIN  
NORTON, VERMONT

NORTON POND DAM  
VT 00198

PHASE I INSPECTION REPORT  
NATIONAL DAM INSPECTION PROGRAM

JANUARY 1979

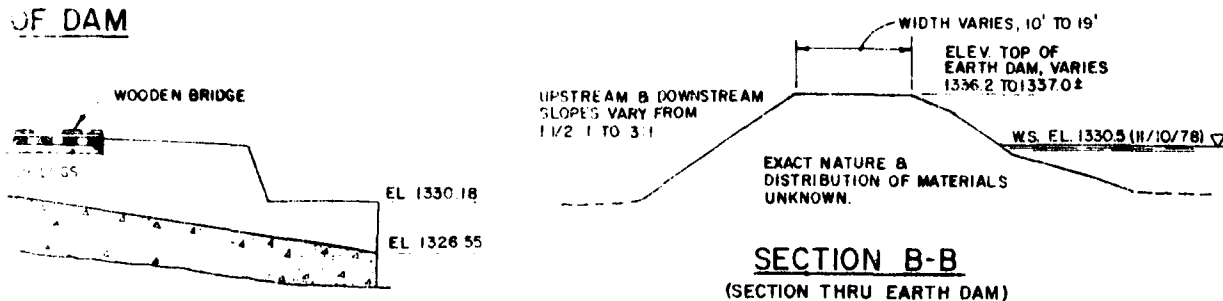
# SECTION A-A (SECTION THRU SPILLWAY)

The spillway structure consists of a concrete sloped slab with flash boards located at the upper face as shown on Section A-A, Figure 1, located in Appendix B. The concrete surface of the spillway slab appeared to be in generally good condition. The training walls and intermediate pier supporting the log roadway bridge, however, are heavily cracked and spalled. The extent of this deterioration can be seen in Photos 20, 21, 22, 23 and 24.
